This report is the result of research commissioned by the Environment Agency's Evidence Directorate and funded by the joint Flood and Coastal Erosion Risk Management Research and Development Programme.

Laura Thomas and Rachael Brady

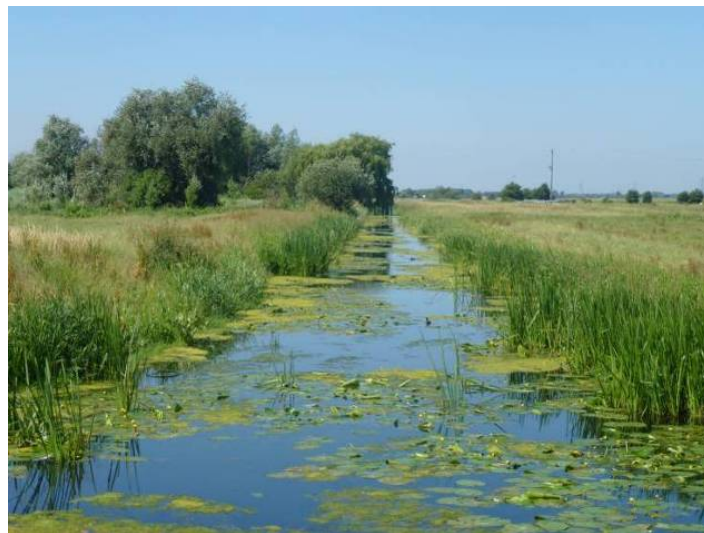
Figure 4-2 Vegetation at Little Bridge

In the marginal areas gypsywort *Lycopus europaeus*, great willowherb *Epilobium hirsutum*, reed sweet-grass *Glyceria maxima*, yellow iris *Iris pseudacorus* and meadowsweet *Filipendula ulmaria* were recorded. Figure 4.2 shows vegetation at the site.

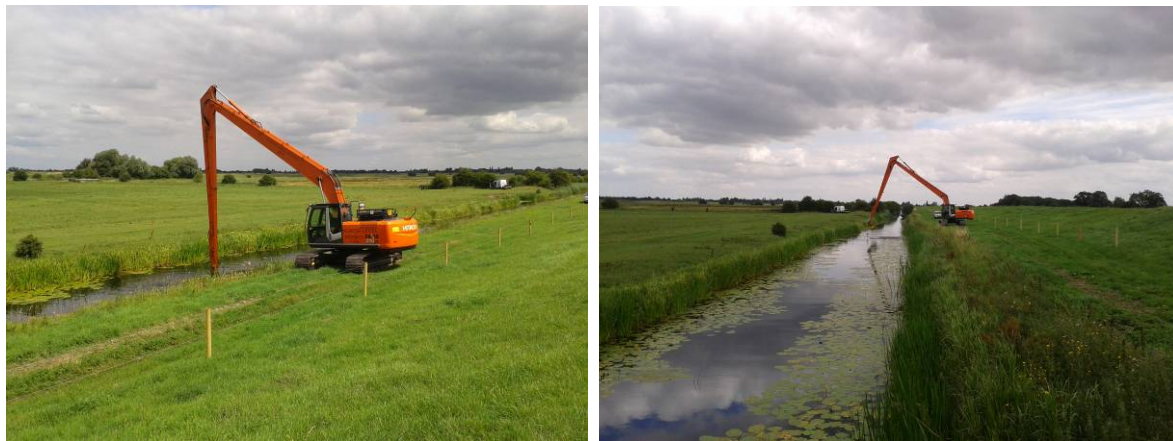
Figure 4-4 Management of Moretons Leam, August 2013 (courtesy Paul Sharman, North Level IDB)

Moretons Leam was managed by the North Level IDB in August 2013, using an excavator fitted with a weed cutting bucket. All management was conducted in accordance with the agreed management plan (Environment Agency 2013b).

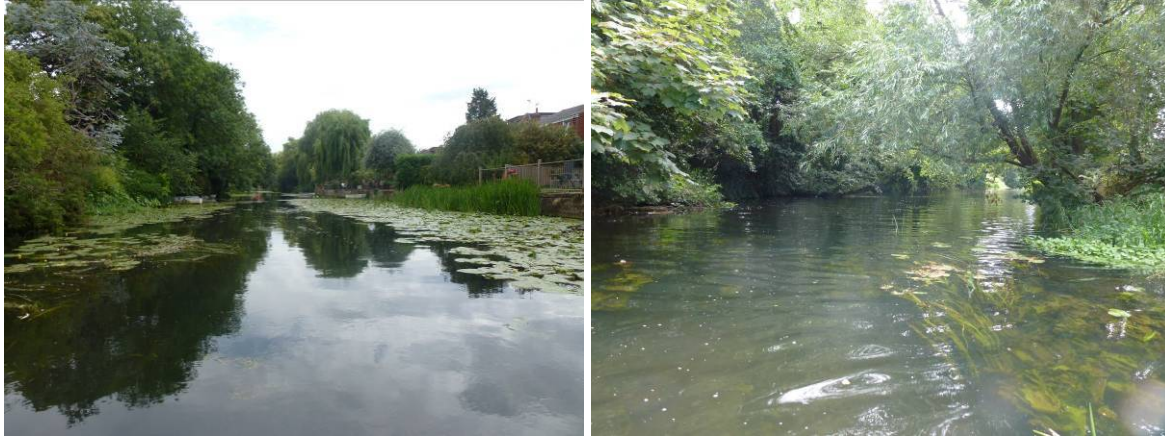
Figure 5-2 The River Mole

The river is heavily modified throughout the surveyed reach, which is unsurprising given the highly urbanised nature of the area. Both banks of the river have properties and gardens backing onto the river for a large majority of the surveyed reach with bank protection and modifications evident throughout. There are also numerous weirs, sluices and bridges across the river.

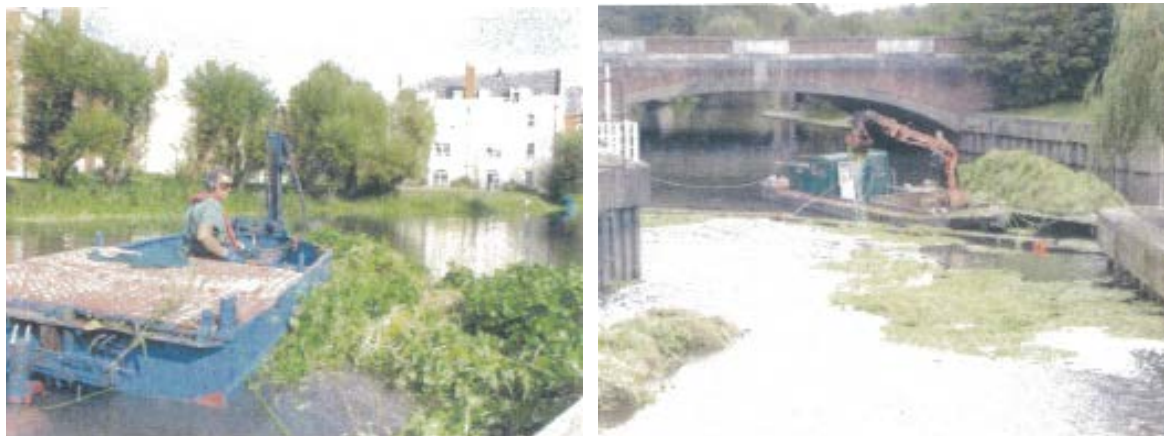
Figure 5-6 Control in September 2002 using weed boats and tugs to collect arisings at Zenith Weir (courtesy Michele Cooper, Environment Agency)

Mechanical methods, using weed boats (Figure 5.6) and long-reach excavators (Figure 5.7) have been tried but the level of fragmentation with these techniques, and the potential for downstream spread, was considered to be too high.

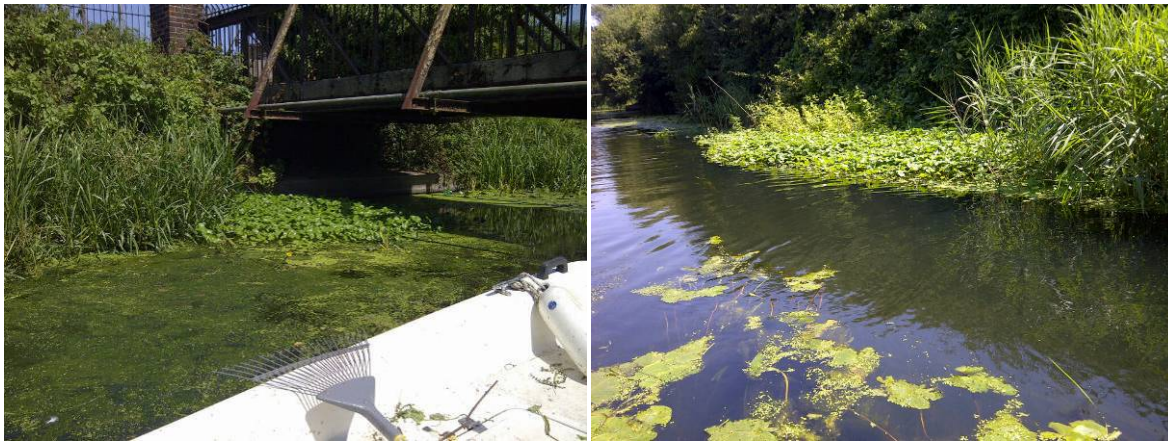
Figure 5-9 Floating pennywort on the River Mole, August 2013 (courtesy Michele Cooper, Environment Agency)

Updates on the management of floating pennywort throughout 2013 were provided by the local Environment Agency officer. Regular management by hand from a boat was conducted to keep on top of the infestations, which remained small and much more manageable with the adoption of this early intervention approach. It was estimated that one week to 10 days a month were spent hand pulling this species during the summer, with the work undertaken from a boat (Environment Agency, personal communication). This allowed the infestations to remain small and under control. This regular hand pulling approach is also proposed for 2014.

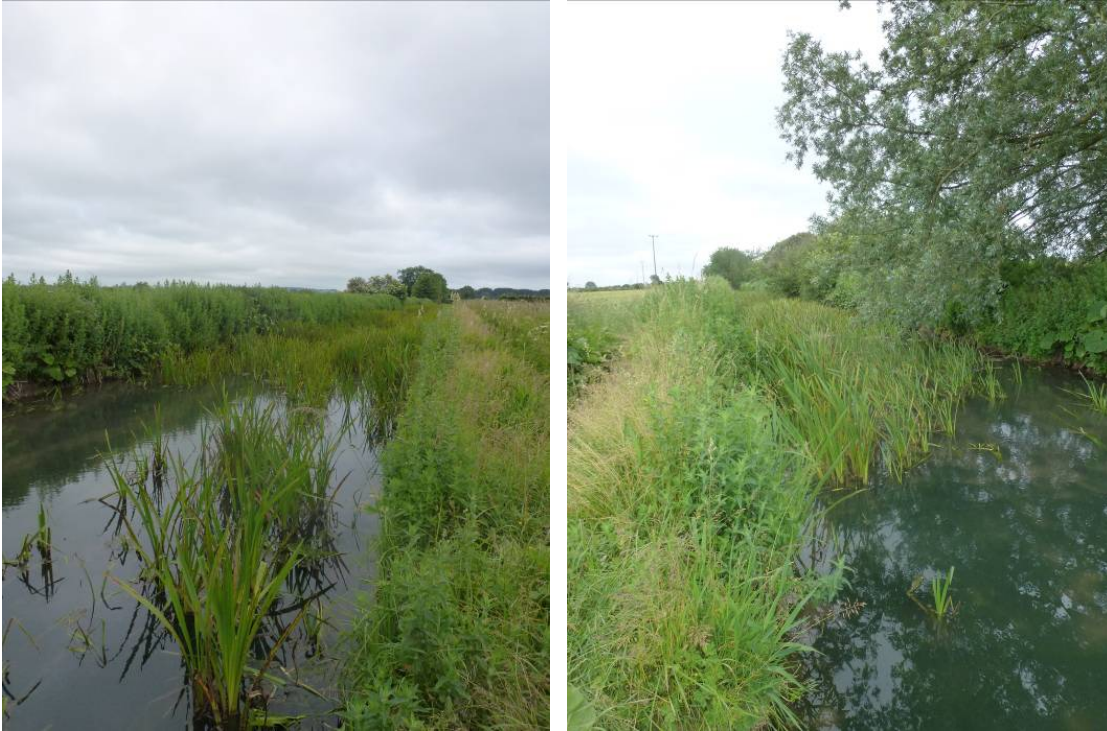
Figure 6.2 Fixed point photograph location: looking upstream (left) and downstream (right)

Within the section surveyed, Nafferton Beck is a wide (approximately 4–5 m), shallow, slow-flowing watercourse, with relatively low banks (approximately 1–1.3 m in height) (Figure 6.2). The substrate is predominantly gravels with some silt.

- Fixed point photography locations were established (at easily accessible locations) with a photographic record taken of watercourse and vegetation conditions prior to management. Where possible, a second visit was made following maintenance to compile a photographic record of the watercourse response post-maintenance. If possible, the watercourse managers were asked to take regular photographs from the established fixed points throughout the weeks/months following management to determine recovery rates and response to management.

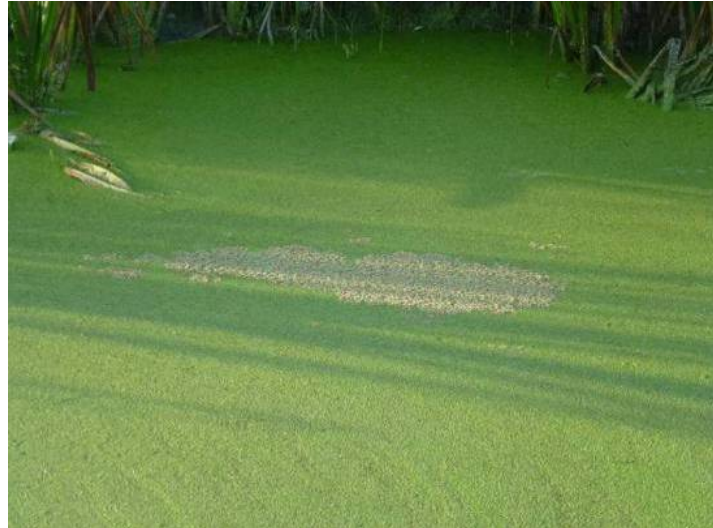
Figure 7-3 Water fern patches within Boating Dike

Within the common duckweed coverage across the water surface were occasional small patches of the non-native invasive species water fern *Azolla filiculoides* (Figure 7.3). Given the

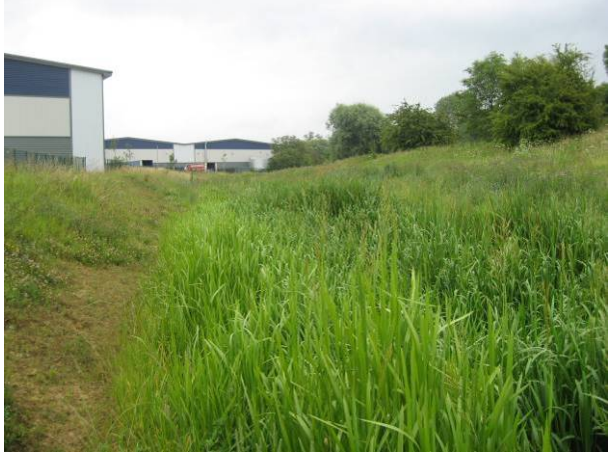
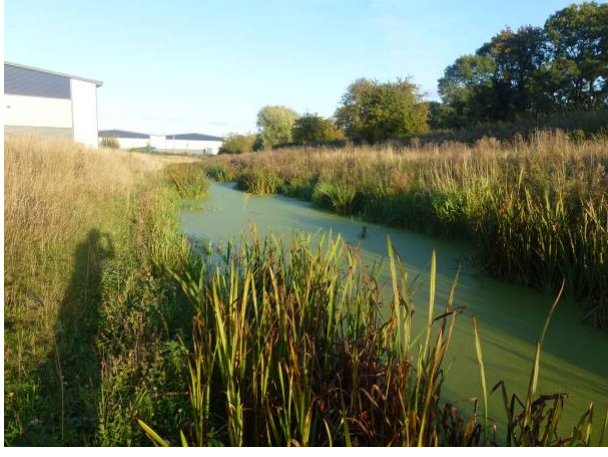
Figure 7-6 Fixed point photography at Boating Dike (courtesy Black Drain DB)

2010	In-channel tall emergent vegetation is very extensive, covering the majority of the channel width.

2011	In-channel tall emergent vegetation is very extensive, covering the majority of the channel width, with increasing proportions of reed sweet-grass.

2013	One year following glyphosate-based herbicide application, the sprayed central channel is now clear of tall emergent species, with a marginal toe retained, although common duckweed now completely covers the water surface.

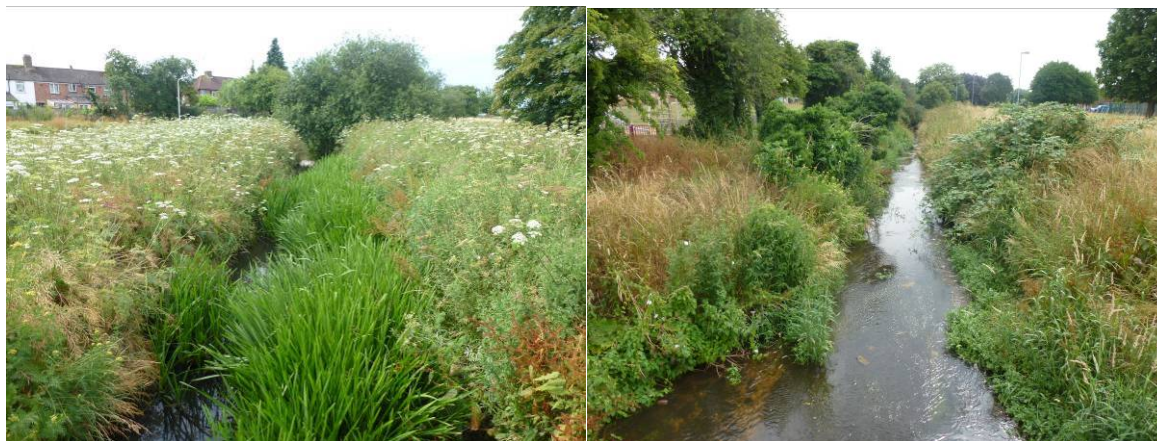
Figure 8-2 The River Lee

The River Lee is a chalk stream (Figure 8.2) and therefore has low flows in summer, but potentially high winter flows. The section requiring management (Figure 8.1) is approximately 3–4 m wide, with water depths when surveyed of approximately 0.5 m, although bank heights tended to be significantly higher than this (approximately 1.5–2 m). Water flow was moderate and the substrate a combination of gravel/pebbles and sand.

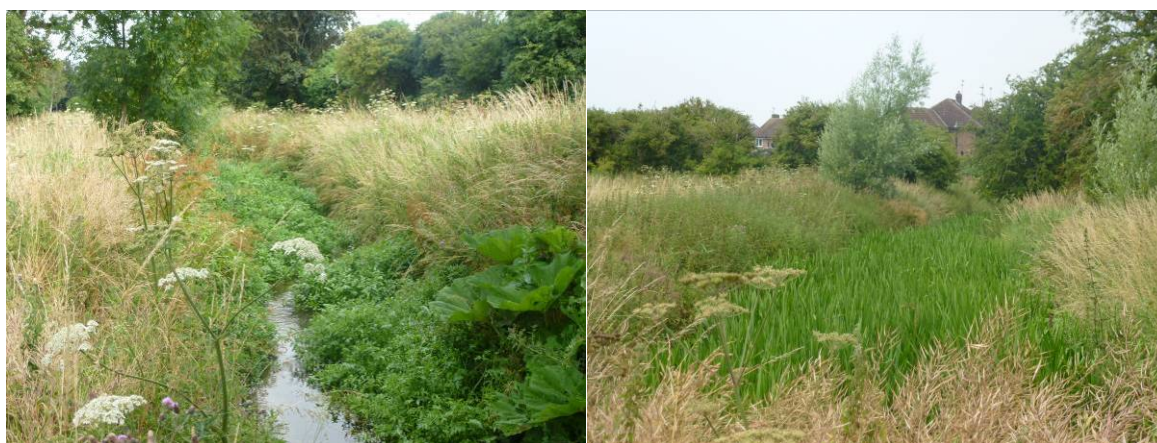
Figure 8-3 River Lee showing problematic broad-leaved emergent growth (left) and tall emergent growth (right)

Within the length of watercourse to be managed, two species types are problematic:

- tall emergent species, primarily branched bur-reed *Sparganium erectum*, but there are also some stands of reed sweet-grass *Glyceria maxima* and reed canary-grass *Phalaris arundinacea*
- broad-leaved emergent species, primarily fool's water-cress *Apium nodiflorum*, with occasional water-cress *Rorippa nasturtium-aquaticum*

Both the tall emergent and broad-leaved emergent species impede the flow of flood waters and cause the accumulation debris which can cause blockages. The broad-leaved emergent species can also cause blockages themselves if they become dislodged during high flows. As summer flooding can be an issue on this watercourse, the dense growth of these species during the summer can be problematic. However, prolonged rainfall in winter can also cause issues. The aim of maintenance on this watercourse is therefore to keep flood flow capacity at optimal levels by keeping the channels relatively clear of vegetation all year round.

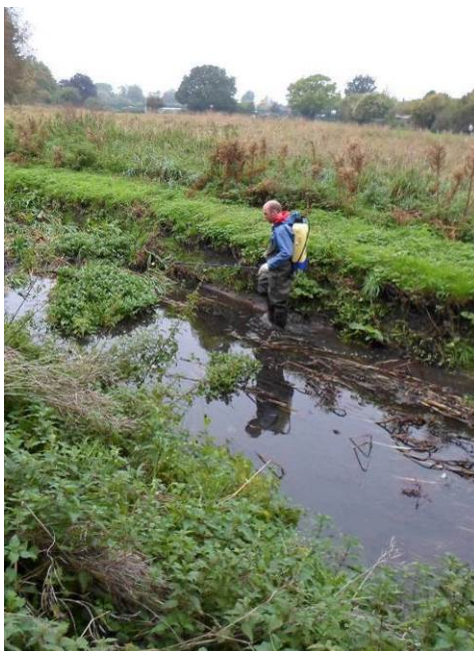
Figure 8-4 Spraying on the River Lee at Luton

The spraying of the River Lee through Luton was undertaken by the Environment Agency in early October 2013 (Figure 8.4). Due to conditions at the time not all sections originally intended for treatment were sprayed, with Fallowfields, Lewsey Brook and Houghton Brook not managed with glyphosate-based herbicide. Several sections of the River Lee through Luton were treated.

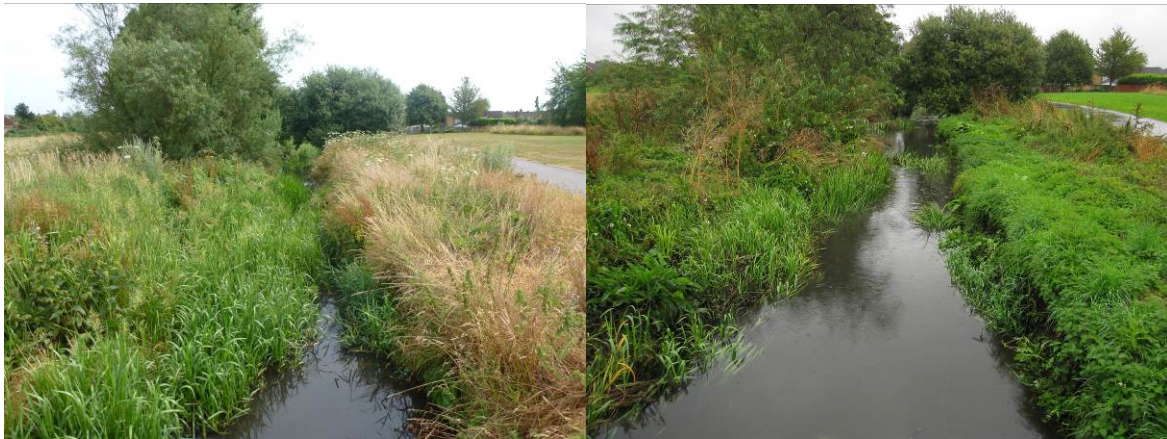
The re-survey identified that, on the sections of the River Lee that had been sprayed, a good level of control had been achieved, with the extent of in-channel growth of the problem tall emergent (branched bur-reed, reed sweet-grass and reed canary-grass) and broad-leaved emergent species (fool's water-cress, water-cress) considerably reduced.

Figure 8-6 The River Lee in Luton prior to management (left) and one year following treatment with a glyphosate-based herbicide

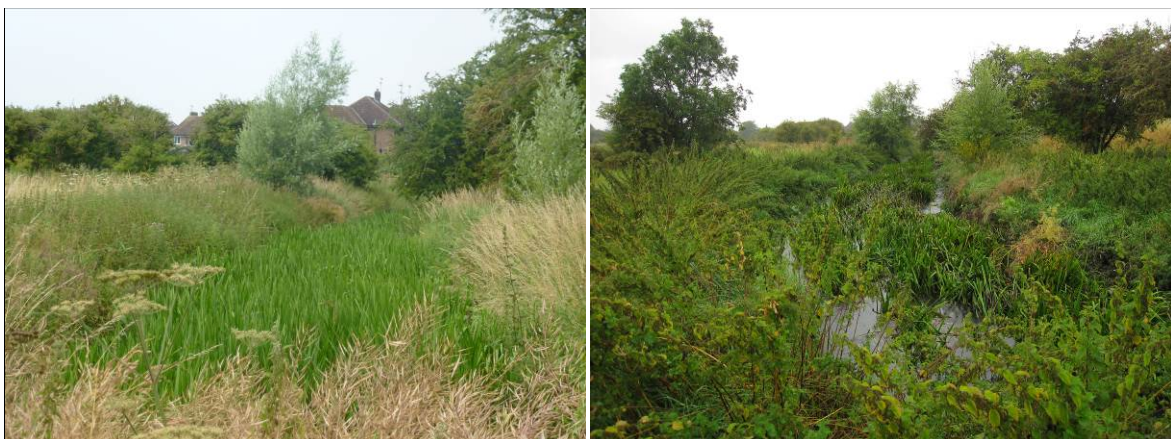
On those channels where spraying with a glyphosate-based herbicide had not been conducted, vegetation growth was consistent with that observed in 2013. This can be seen in Figure 8-7, below, with dense branched bur-reed evident across the full width of the channel in both. In the 2014 photo the branched bur-reed has already started to die-back, most likely due to the very early spring experienced in 2014 resulting in earlier than usual die-back.

Figure 8-7 Untreated section of the River Lee at Fallowfields (2013 on the left; 2014 on the right)
